The Hydrology of Nailsea Terry Smith 6th July 2013

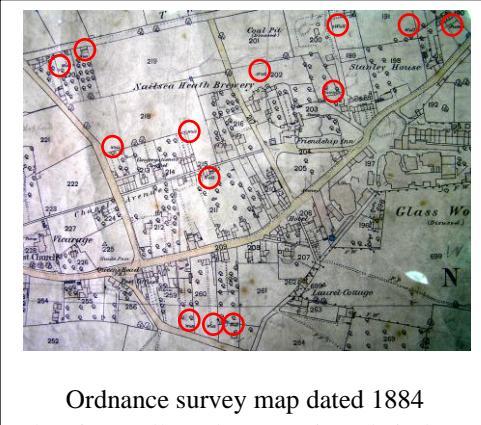
Ordnance survey map dated 1884 showing wells and pumps (in red circles).

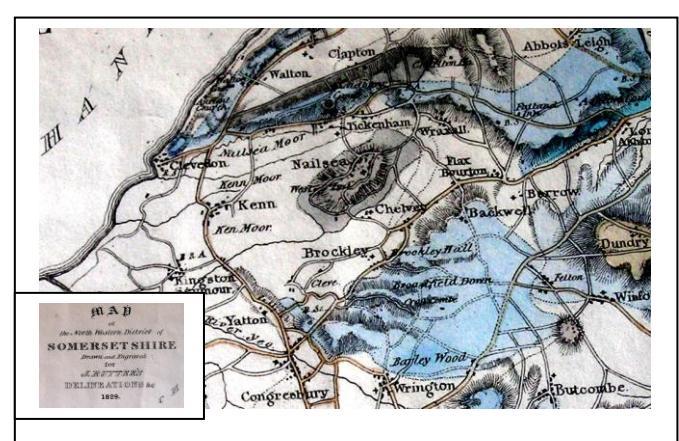
Map reproduced from Rutter's Delineations (1829) showing the topography and geology of Nailsea

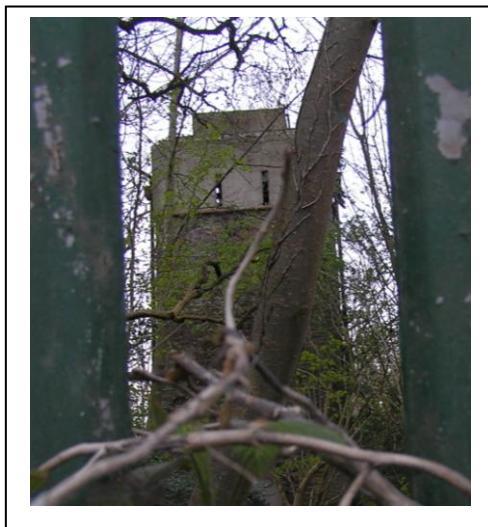
Engine house at Middle Engine Pit. The tank on top of the tower was used to store water for the Elms private house. ST 482 706

Several water towers were built to provide a head of water for local domestic supply, but few of these remain. The engine house at Middle Engine Pit (closed *ca* 1850) was used to support a cistern to supply water to the

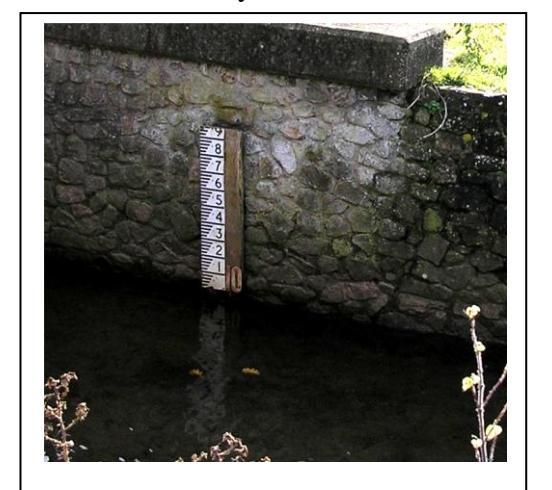
Gauge at Jacklands Bridge marked at 10 cm intervals ST 469 717

the Land Yeo are monitored visually by the Environment Agency in the vicinity of Nailsea at Jacklands Bridge and on land belonging to Tickenham Court, and there is a remote sensor at the head of the Birdcombe Valley opposite Wraxall Mill. The deeds of Wraxall House were unfortunately destroyed by flood in a Bedminster bank vault in 1968 and some of these issues may never be resolved

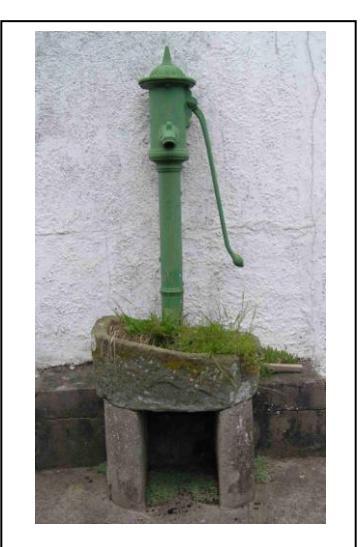
Pump at Youngwood House Farm

A well sunk close to Youngwood Farm is still open, surmounted by the original pump probably made in 1875. The cylinder may still be in the well, the pump head actuating the plunger by a connecting rod which may be seen in the photograph.

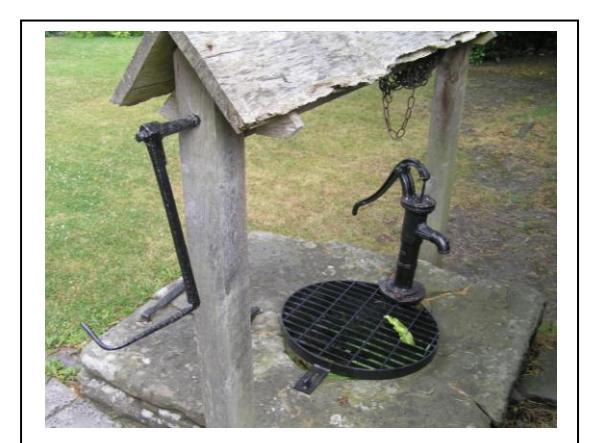
Well in the front garden of a house in Heath Road (ST 47443 71058). (photograph by courtesy of Lin and Mel Capon).

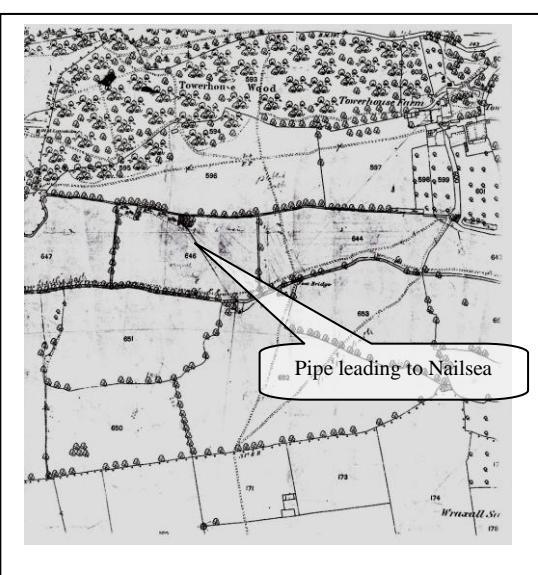
Map dated 1886 showing the line of the pipe leading from the Birdcombe Valley to the Brewery in Nailsea

Powered pumps for the supply of water to Nailsea Thatcher's brewery was founded in 1740, operating on the site now occupied by Heath Road and Friendship Road. Glass blowing is an occupation in which there is a need to replenish water lost due to the heat of the furnaces. The brewery therefore flourished when the glass works were established in 1788 by supplying drinks to the glass workers. The Glasshouse Inn was therefore established to serve the workers, and 70 years later the name was changed to 'The Friendship'. The brewery also produced lemonade with the slogan 'Heath for Health'. Several bottles have been recovered on the site bearing the name 'Heath Mineral Water Nailsea'. The local glassworks had closed in 1873 and these bottles marked JL&Co appear to come from John Lumb of Castleford, Yorkshire. A water pump powered by an undershot wheel in the flow of the Land Yeo was installed at Knightswood spring in the Birdcombe Valley by Thatcher's brewery at a cost

of £200 in ca 1850. A small steam engine was used to pump the water when the flow in the river was insufficient. A pipe was laid to carry the water to Nailsea and way-leave was offset by allowing access to the water in three of the fields traversed by the pipe. Some of the pipe work still remains in the river in the Birdcombe Valley (see photograph), and there have been reports of the pipe being exposed when foundations were put in for the houses on the estates in Woodland Road in 1969. There was a large cistern (now destroyed, see photograph) next to the

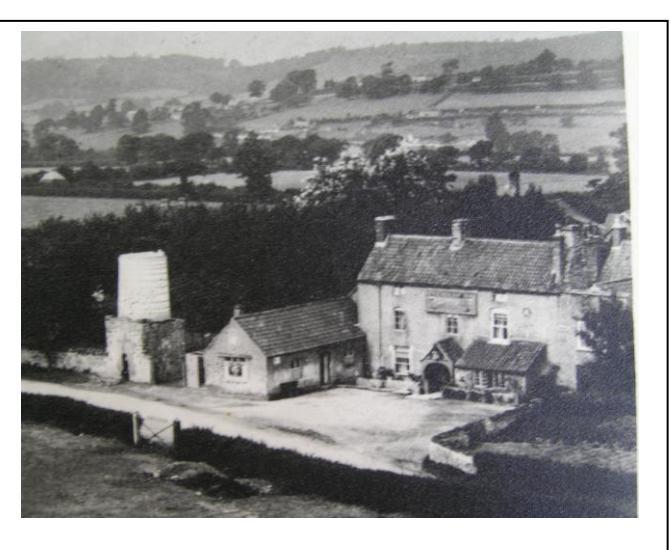
Water pumped from the Land Yeo was stored in a reservoir adjacent to the Friendship Inn, (white tower to the left)

Friendship Inn in 1968. It seems that this was built as a tribute to Queen Victoria for the storage of the water that was sourced from the Land Yeo (Basil Greenhill, in 'Old Nailsea' 1959). Any water that the brewery did not need was made available to the local people. A stone carved with the word 'Jubilee' (probably referring to Oueen Victoria's diamond jubilee in 1897) is all that remains of the water tank. This stone was originally inserted at the top of the brickwork of the tank. The pump fell into disuse in 1905 when mains water was provided for the Town.

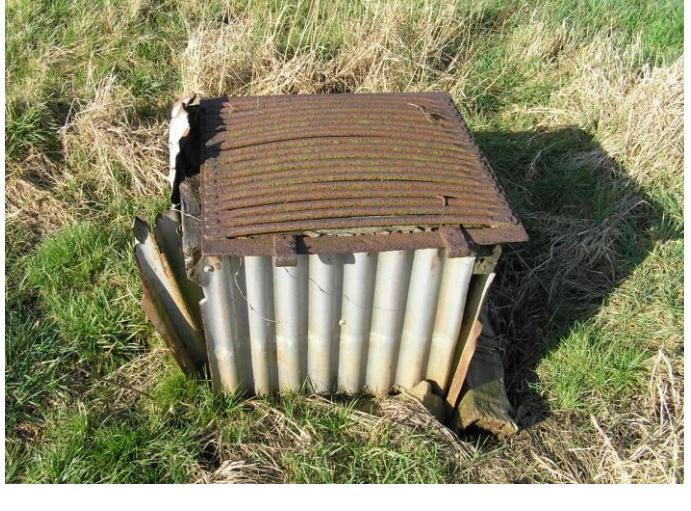
Access shaft for Jacklands Tunnel at Moorend Spout (26 February 2012) ST 4669 7155

Some of the water that originally flowed in the field is ducted in a pipe about 2 metres below the surface, now known as Jackland's Tunnel. This drain carries quite a large quantity of water, which apparently originates at the sluice on the Clevedon Road. There are (at least) two

inspection shafts (one is in the six acre field that belongs to NEWT, see photograph). This drain was laid in 1804 when much of the marsh was drained. The style of the ironwork above the shafts supports the suggestion that they are very old. The tunnel (marked Jacklands Tunnell, sic.) is shown in the map on page 40 of the book by David Franks, (The Story of Tickenham, 2000). The height of the water table may be also reduced by Jackland's Tunnel, which acts as an efficient drain.

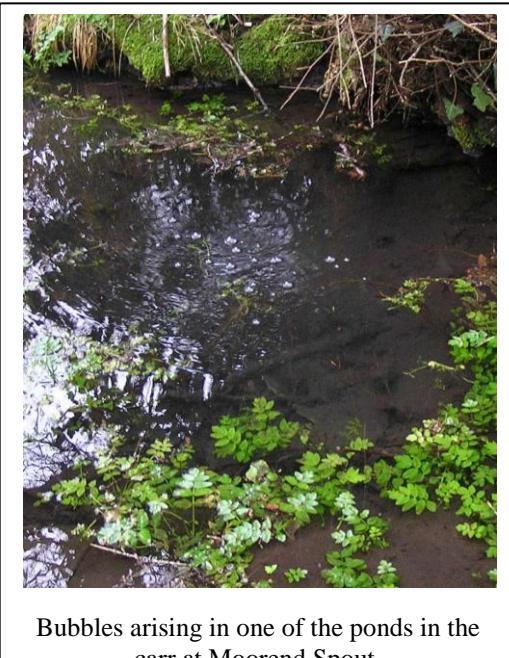
carr at Moorend Spout. Similar bubbles are found in other springfed ponds in this area.

Gas arising from ponds The pond in Towerhouse Wood (ST 475 719) is well known for the production of gas bubbles apparently associated with the spring water that fed the pond. Analysis by British Gas showed that this gas was mainly air with 8% of carbon dioxide. An investigation by Sarah Davies of the Environment Agency (EA) in 2008 showed that the temperature of the water in the vicinity of the springs was 2°C higher than that of the surrounding water.

This may not be so surprising in view of the hot springs that are found at Bath and also in Hotwells Road in Bristol. Although this may seems to be a small differential, I understand from the EA that in this area any water emerging as a spring with a temperature in excess of 10°C is likely to be of thermal origin. The results therefore seem to be in agreement with a 'hot rock' hypothesis for the production of the bubbles (See Pennant 28, p.20). A pond in the carr at Moorend Spout similarly produces large gushes of bubbles at intervals (see photograph above). The occurrence of hot rocks close to the

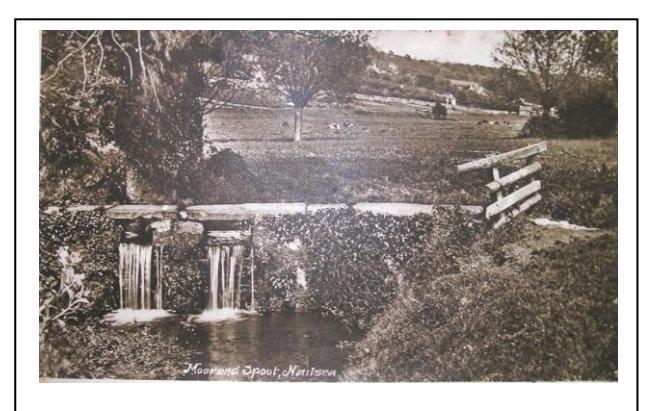
Photograph of a picture post card showing the sluice at Moorend Spout, posted in 1931
